AN INVESTIGATION OF A THERMAL ICE-PRE-VENTION SYSTEM FOR A TWIN-ENGINE TRANSPORT AIRPLANE

## REPORT No. 862

# AN INVESTIGATION OF A THERMAL ICE-PREVENTION SYSTEM FOR A TWIN-ENGINE TRANSPORT AIRPLANE

Ames Aeronautical Laboratory Moffett Field, Calif.

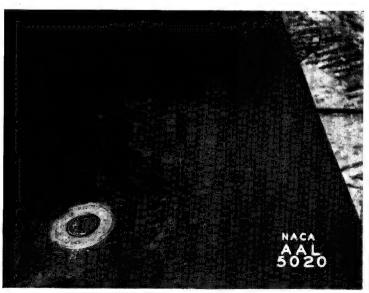
FIGURE 28.—Ice removed by engine warm-up and take-off in simulated icing tests.

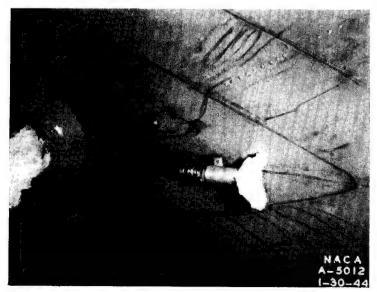
FIGURE 30:—Ice accumulation on pilot's free-air temperature thermometer after flight 29.

Photograph taken after landing.

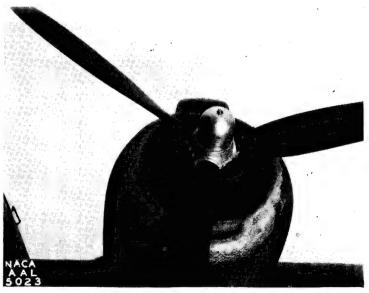
Figure 32.—Ice accretion on the  $\,$  eft engine cowl after flight 50.
